## Introduction

Prior to the surgery, all patients undergo MR imaging. The results of the imaging studies and the findings at the time of surgery have differed. The purpose of this review was to compare the radiographic appearances with the gross appearances of the spinal cord at the time of surgery.

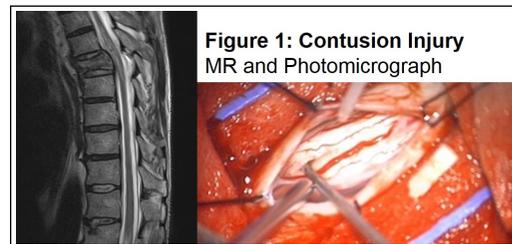
Figure 1: Contusion Injury MR and Photomicrograph

In the 3 contusion-type injuries, a midline myelotomy was performed. In each, necrotic and hemorrhagic material expressed itself through the

myelotomy. After microirrigation with saline, a well-formed cavity was evident in the central portion of the spinal cord. The scaffold was inserted into this cavity.

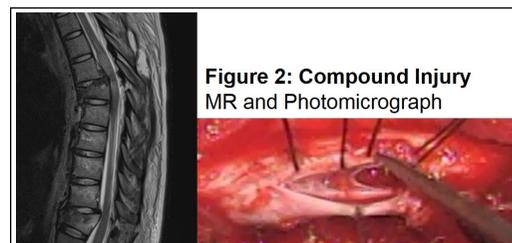
Figure 2: Compound Injury MR and Photomicrograph

In the 2 compound-type injuries, the white matter was clearly violated and a cavity was evident extending from this point into the spinal cord. Again, following microirrigation of the cavity, a scaffold was placed with the cavity. As each of these cases involved unstable fracture-subluxations to varying degrees, internal fixation with spinal instrumentation/fusion was performed.
